# Introduction

## **The Purpose, Method and Composition**

## Chapter 1 : The Purpose, Method and Composition

## 1.1 Purpose

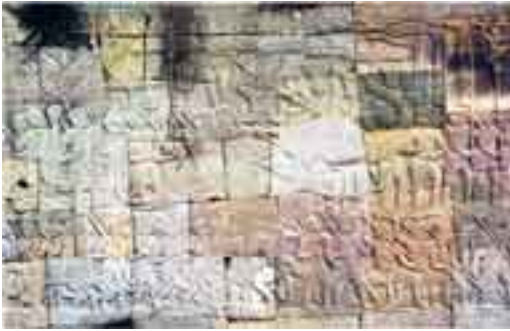
Pl. 2.6-1 The gray to yellowish brown sandstones used for the Outer gallery of Bayon. The size and shape of the sandstone blocks are variable and the stacking of the blocks seems to have been performed without a plan.

バイヨンの外回廊に使われている灰色～黄褐色砂岩。砂岩材の大きさと形は変化に富み、砂岩材は無計画に積まれたと推測される。

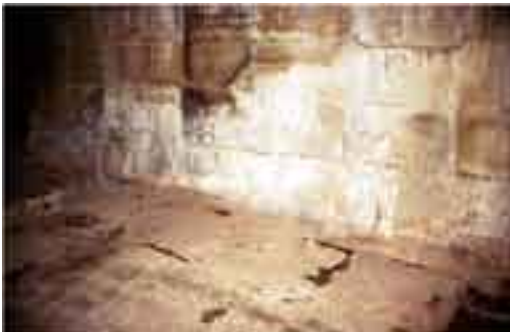
Pl. 2.6-2 The exfoliation of the sandstone blocks by salt weathering due to bat excrement in the lower part of the inner wall in the Inner Gallery (west side) of Bayon.

バイヨン内回廊（西側）の内壁下部に見られるコウモリの排泄物に起因する塩類風化による砂岩材の剥離。

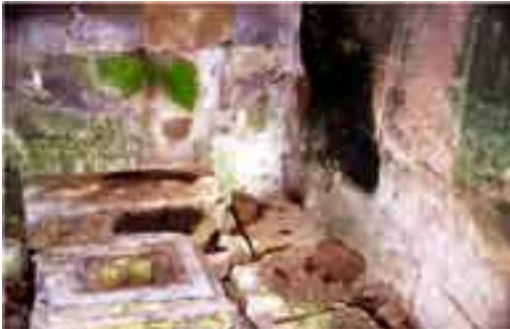
Pl. 2.6-3 The exfoliation of the sandstone blocks by salt weathering due to bat excrement in the lower part of the inner wall of the Tower 7 in the central part of Bayon.

バイヨンの中心にある第7塔の内壁下部に見られるコウモリの排泄物に起因する塩類風化による砂岩材の剥離。

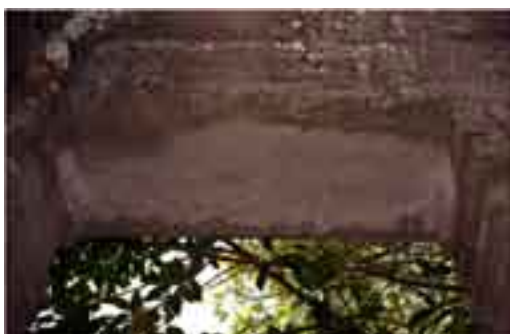
Pl. 2.6-4 The exfoliation due to crystallization of calcite in the under bed of the architrave in the Outer Gallery (East Entrance) of Bayon.

バイヨン外回廊（東側入口）のアーキトレーヴ材下面に見られる方解石の析出による剥離。

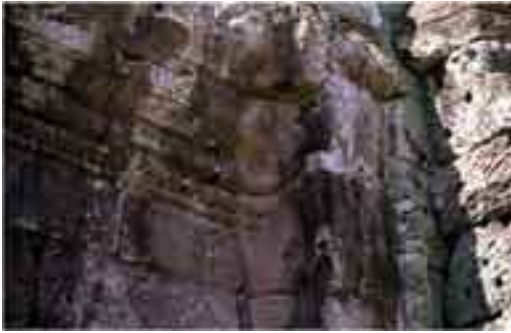
Pl. 2.6-5 Holes formed in the reentrant due to crystallization of calcite in the West Tower on the cruciform platform of Bayon.

バイヨンの十字基壇西側に位置する塔の入り隅に見られる方解石の析出により生成された穴。

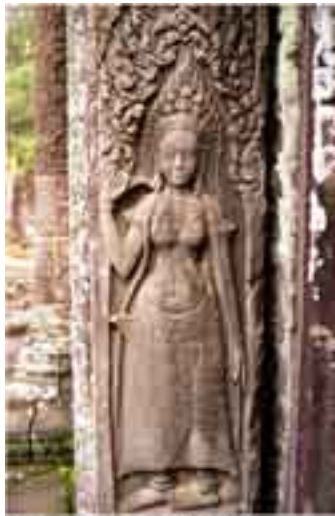
Pl. 2.6-6 Cracks along the bedding planes in the pillar with the vertical bedding planes in the Inner Gallery (south side) of Bayon.

バイヨン内回廊（南側）にある縦層理を持つ柱に見られる層理面に沿った亀裂。

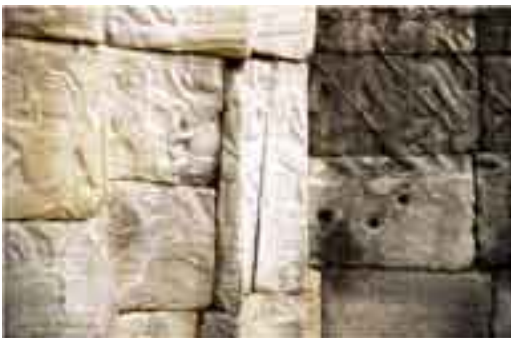
Pl. 2.6-7 Crack along the bedding plane in the gray to yellowish brown sandstone block with the vertical bedding planes in the Outer Gallery (north side) of Bayon.

バイヨン外回廊（北側）にある縦層理を持った灰色～黄褐色砂岩材に見られる層理面に沿った亀裂。

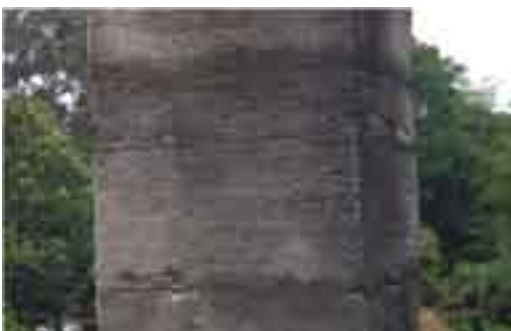
Pl. 2.6-8 Cracks along the bedding planes in the pillar constructed with sandstone blocks with the horizontal bedding planes in the Northern Library of Bayon.

バイヨン北経蔵の水平層理を持つ砂岩材から構成される柱に見られる層理面に沿った亀裂。

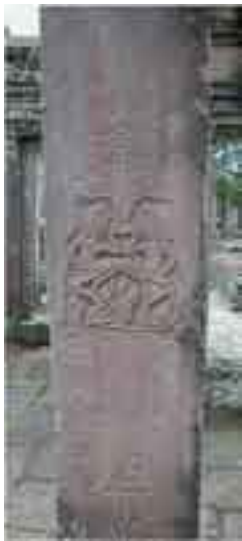
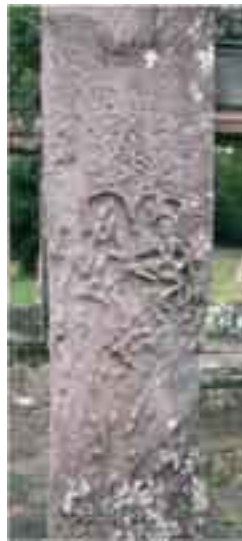
Pl. 2.6-9 Reliefs of dancing Apsaras on the pillars in the southeast corner building of the Outer Gallery of Bayon. (a) intact Apsaras and (b) weathered Apsaras due to tafoni.

パイヨン外回廊の南東角にある建造物の柱に見られる踊るアプサラのレリーフ。(a) 無傷なアプサラと (b) タフォニにより風化したアプサラ。

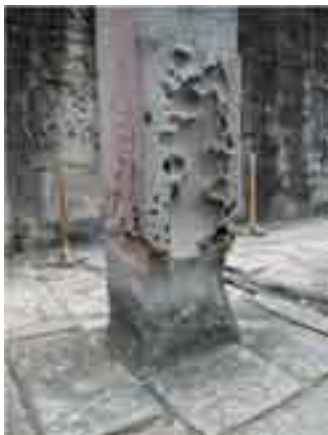
Pl. 2.6-11 Large hole formed by the action of tafoni, observed in the inner pillar of the Outer Gallery (in the south part of the east side) of Bayon.

パイヨン外回廊（東側南部）の内柱に見られるタフォニにより形成された大きな穴。

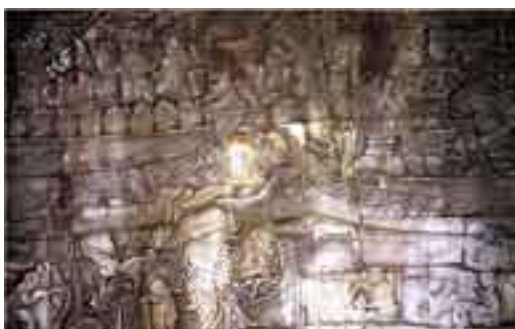
Pl. 2.6-12 Detachment of relief due to heterogeneity of the sandstone block in the Outer Gallery (in the east part of the south side) of Bayon.

パイヨン外回廊（南部東側）に見られる砂岩材の不均質性によるレリーフの剥落。

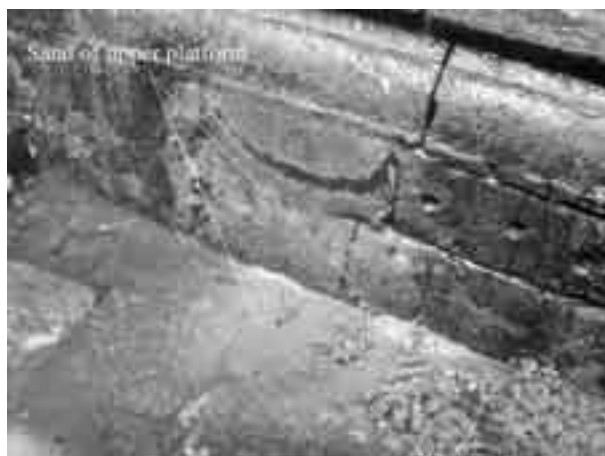
Pl. 2.8-18 After rain, sand from inside of upper platform.

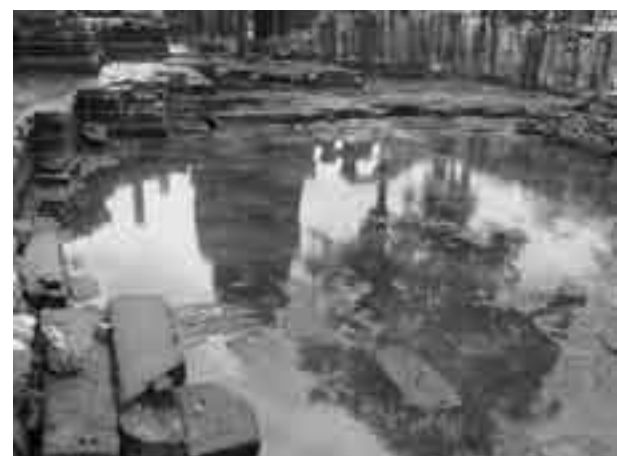
Pl. 2.8-19 After rain, rainwater remained on courtyard ES.

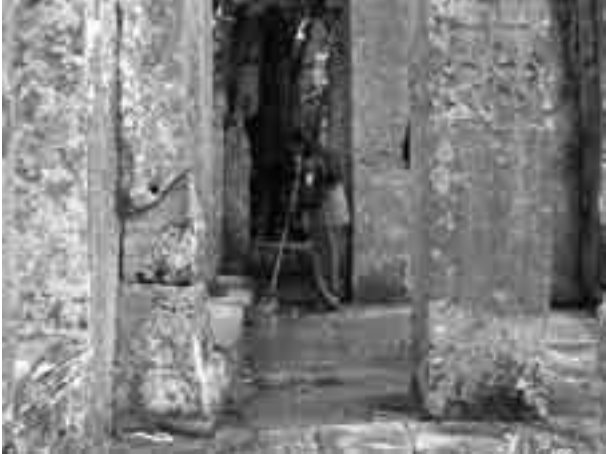
Pl. 2.8-20 Rainwater remained on the pavement of pavilion 55, the lady guard try to sweep and clean the rainwater.
