- Appendix 6 : Building Structural Survey Report of the Bayon Temple
- 6.1 Building Structural Survey of the Bayon Temple and so forth
 - Bayon Northern Library, Prasat Suor Prat, and Angkor Wat Northern Library -

IWASAKI Yoshinori, ARAYA Masato

1. Introduction

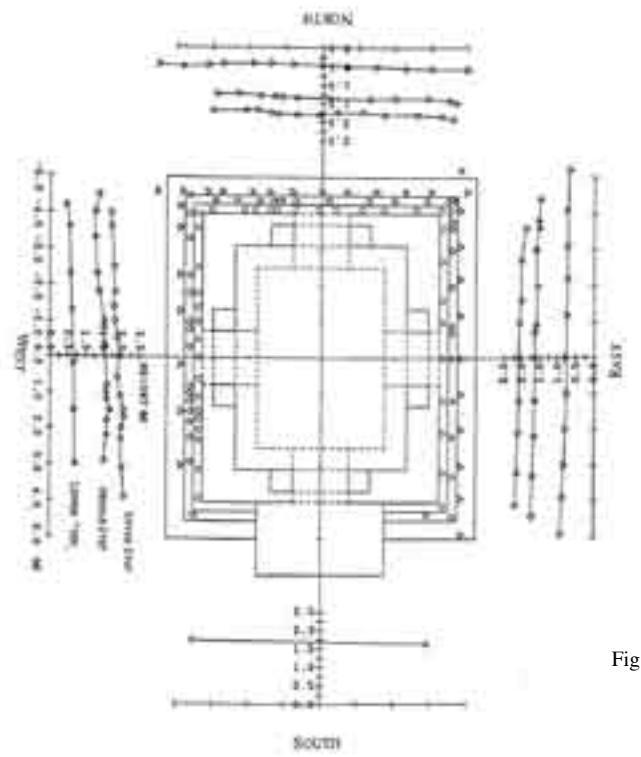
Fig. 6.1-6 Relative level of the foundation of N1 Tower.

In 1998, we conducted a visual confirmation of the danger spots in each tower and the towers' likelihood of collapsing, and discussed possible causes. We also reported that the N towers were more in danger of collapse than the S towers (chapter 2, 5, 1998). Fig.6 shows the relative height of the steps along the peripheral of the foundation.

The platform of the N1 tower, which shows the greatest inclination, was reported as 4/100 in the direction of the North Pond (chapter 4, 1.5, 1995). We presented a case example in which we measured the inclination of the side walls of the towers (chapter 4, 3.6, 1995) (25, 2001). However, in 1997, heavy rainfall caused the N1 tower to tilt more, and thereafter, the tilting movement continued slowly but steadily over several months (chapter 6, 4, 1998).

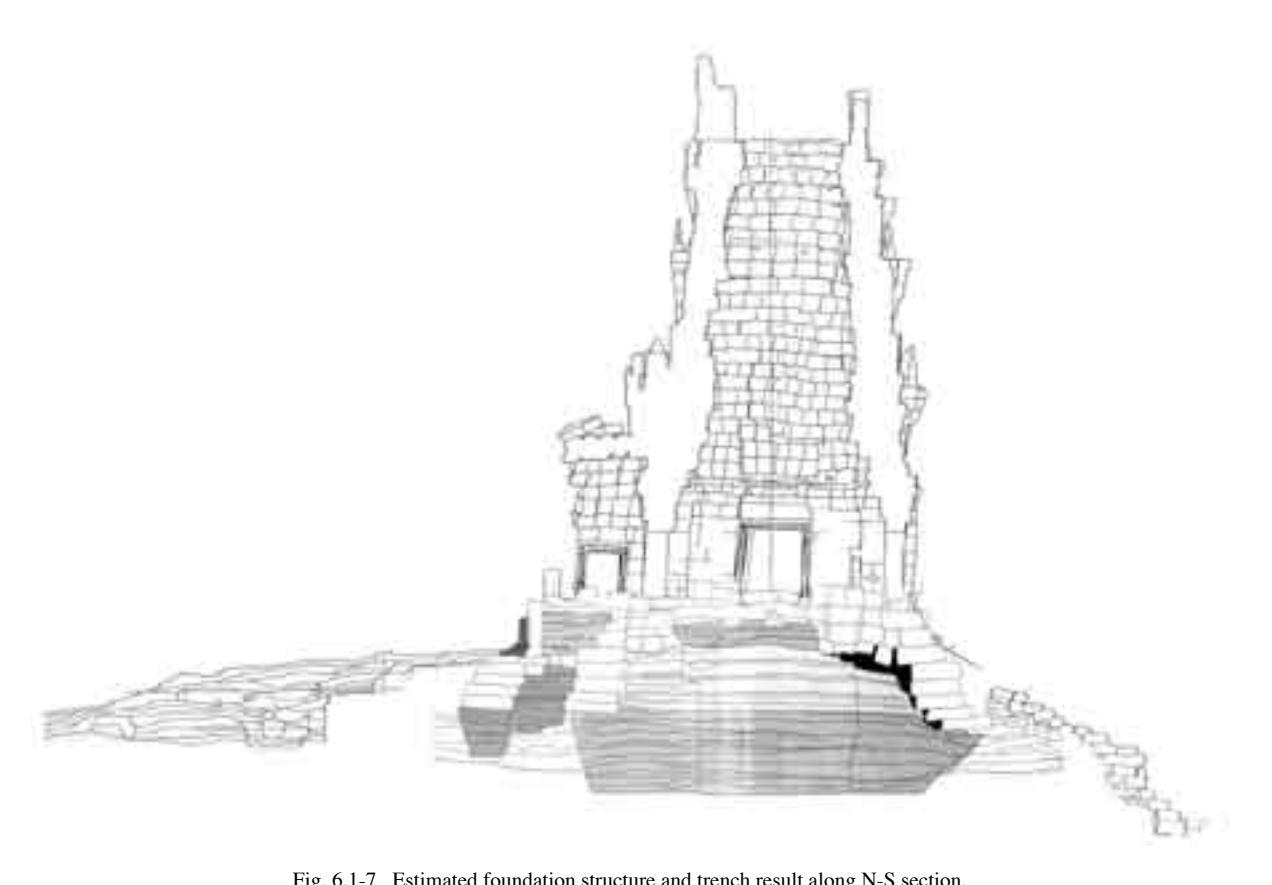
Fig. 6.1-7 $\,$ Estimated foundation structure and trench result along N-S section.

In order to survey the tower structure around the foundation of the Prasat Suor Prat N1 tower, we used a hand auger in the vertical position and at a 30~45 degree angle to estimate the foundation structure beneath the tower and the ground of the tower periphery. We also surveyed the platform cross-section by digging a small trench. As a result, we found that the interior of the platform inside the tower was composed of dirt filling. We also found that the approximately 2.5 m long laterite blocks of the platform were placed so that they gradually open outward, and the width of the dirt filling on the inside of the blocks increases in accordance with the depth. As shown in Figs. 6.1-7 and 8, the cross-sectional structure showed laterite blocks from the ground surface inside the tower to a depth of about 3 meters, and dirt filling below the tower to a depth approximately 2 meters deeper (23, 2001). Trench excavation performed layer also confirmed the same structures.

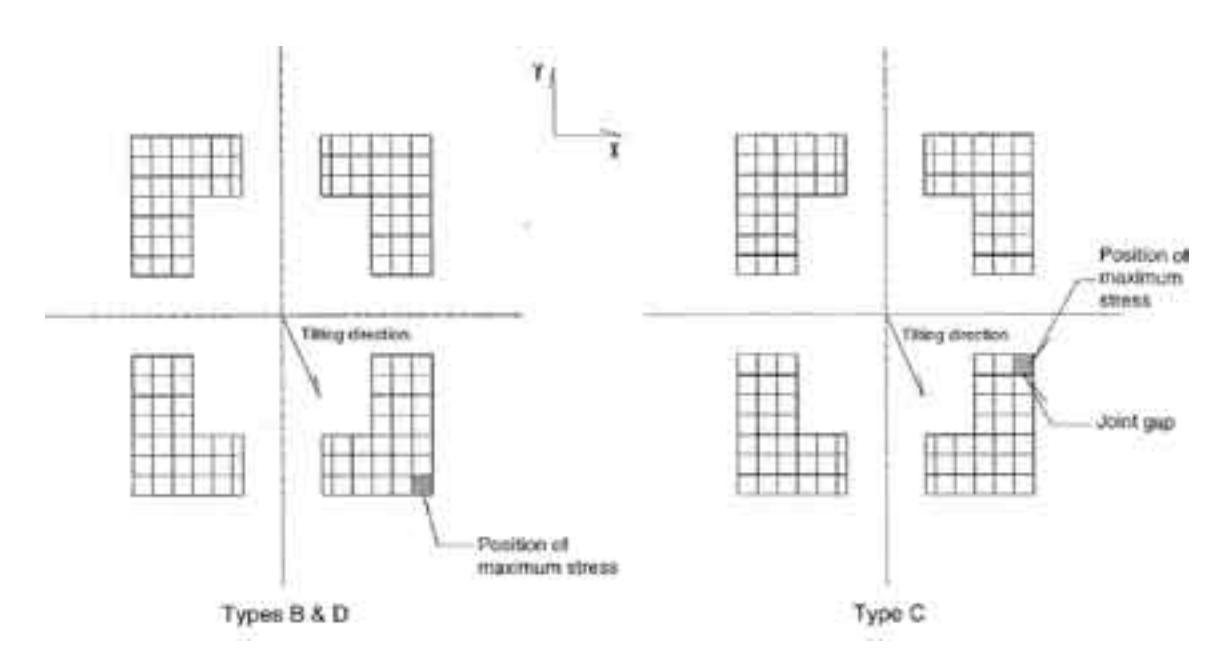
Fig. 6.1-12 Position of concentration of vertical compression stress.

As shown in Fig. 6.1-12, in type B, the inclination of the tower caused the compression stress to become asymmetrical in relation to the center of the tower, and the stress increased roughly 35% because it concentrated on the side of the pond to which the tower was tilted.

Type C simulates the present condition in which cracks have occurred in the tower. If there were no cracks, the arch effect would have dispersed the load directly above the opening. However, because of the slit, the load was not dispersed, but it rather became concentrated on the pilaster of the opening and increased approximately 76%.

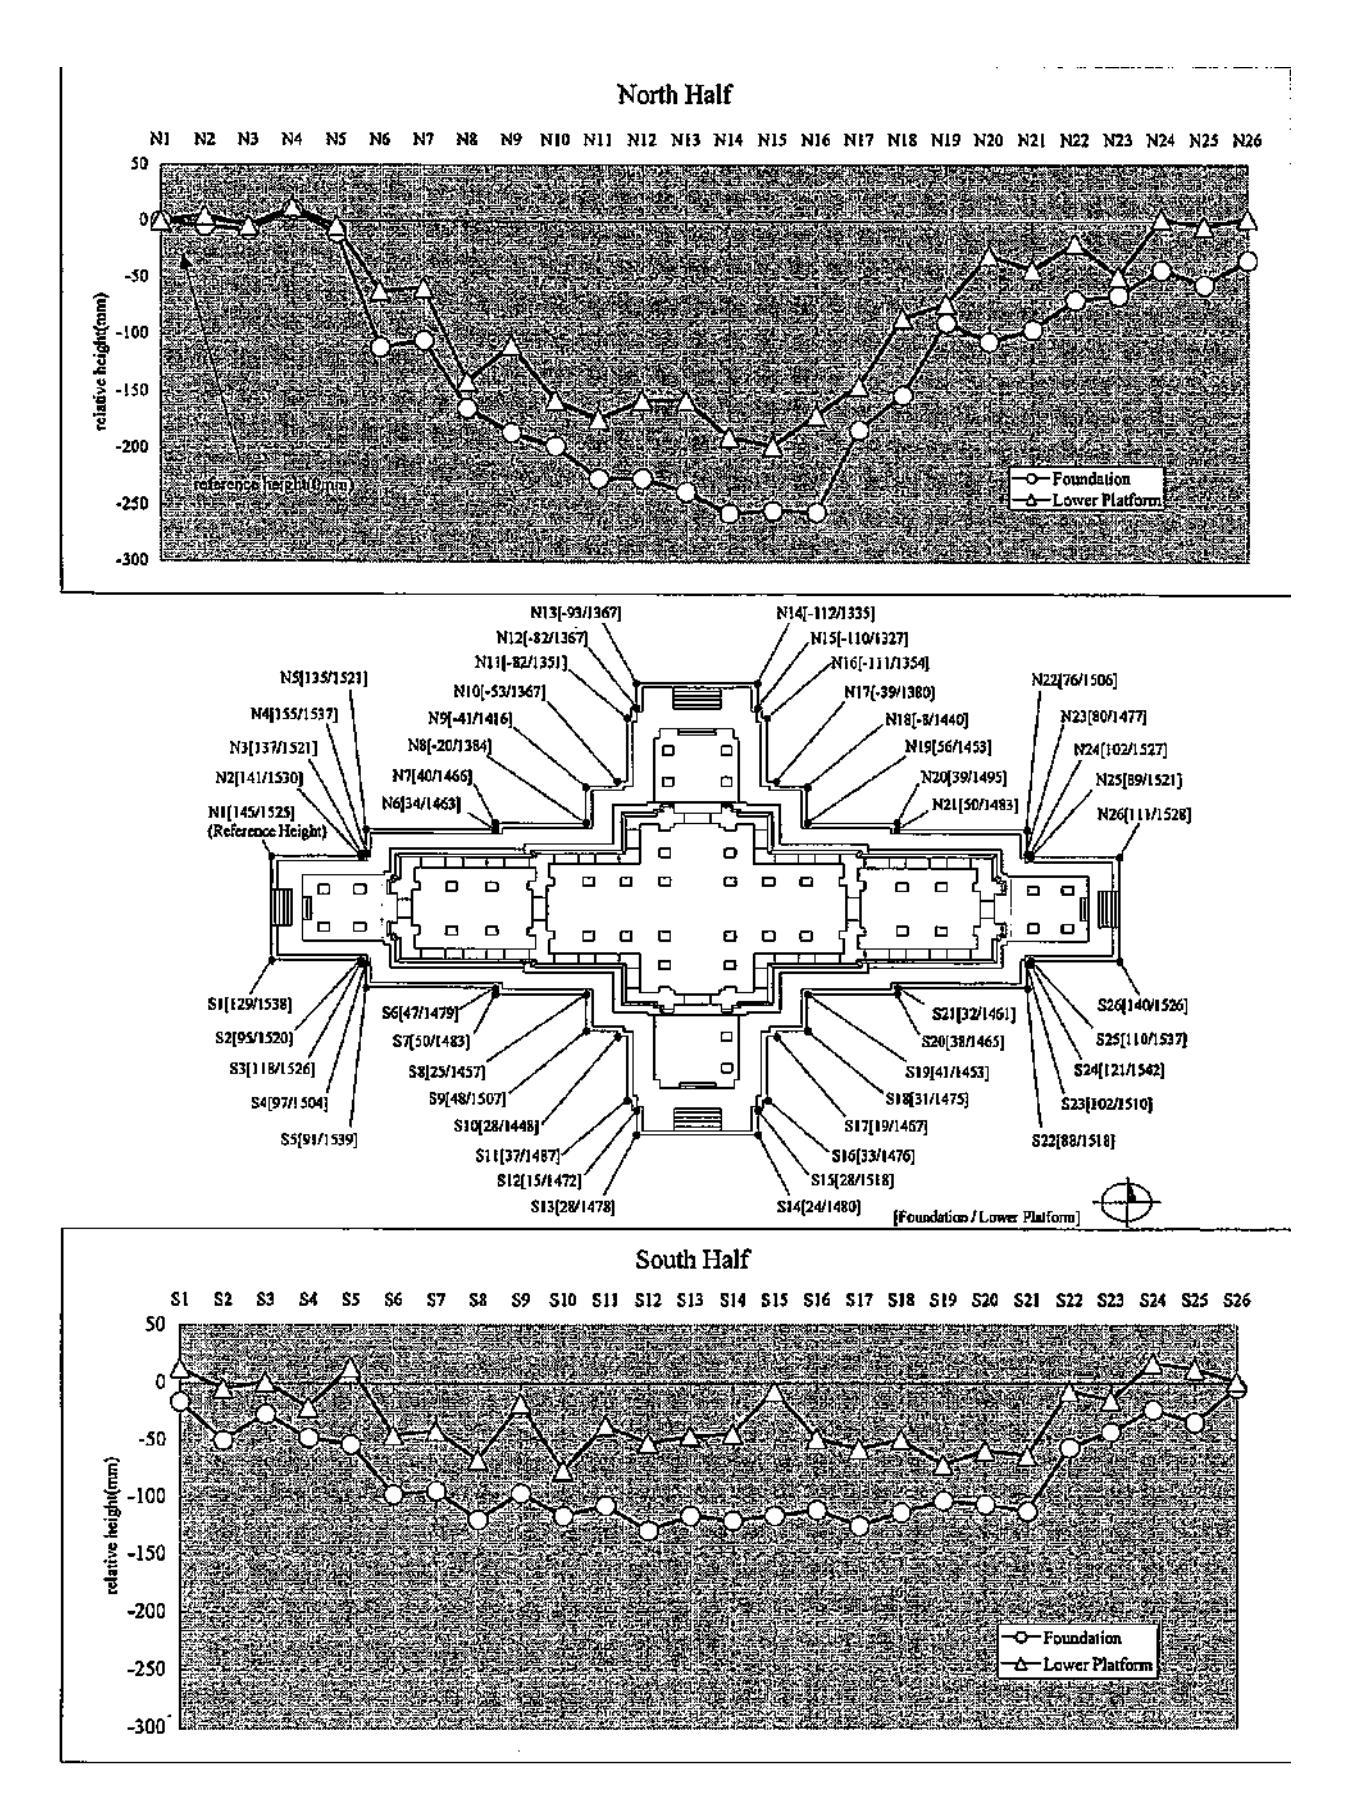
Fig. 6.1-14 Relative level of the foundation and lower platform.

Judging from the measurement results of the height of the structure, the greatest level difference of the foundation base is 0.27 m, and that of the top surface of the bottom platform is 0.21 m (Fig. 6.1-14). The subsidence of the foundation base and the top surface of the bottom platform are linked for the most part, and are probably caused by ground subsidence

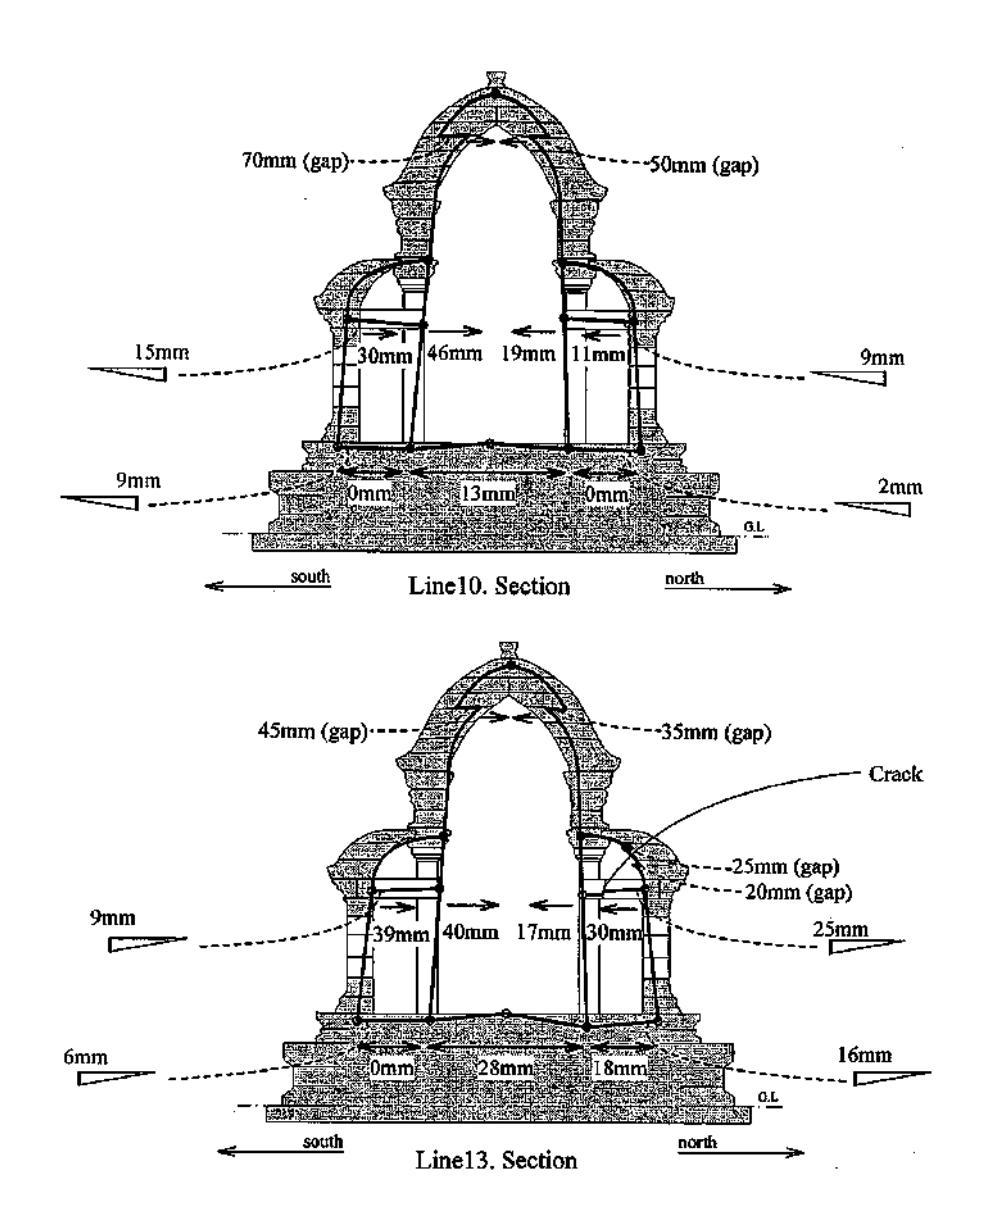
Fig. 6.1-16 Displacement mode in NS direction in Lines 10 and 13 sections.

The deformation conditions of the Wat Northern Library building has been estimated from the results of measurements taken between 1998 and 2001. A comparison of the north, south, east, and west porches show that the east and west porches are the same height and the highest, while the north porch is 250 mm lower and the south porch is 120 mm lower than the height of the east and west porches.
