# Introduction

## **The Purpose, Method and Composition**

## Chapter 1 : The Purpose, Method and Composition

## 1.1 Purpose

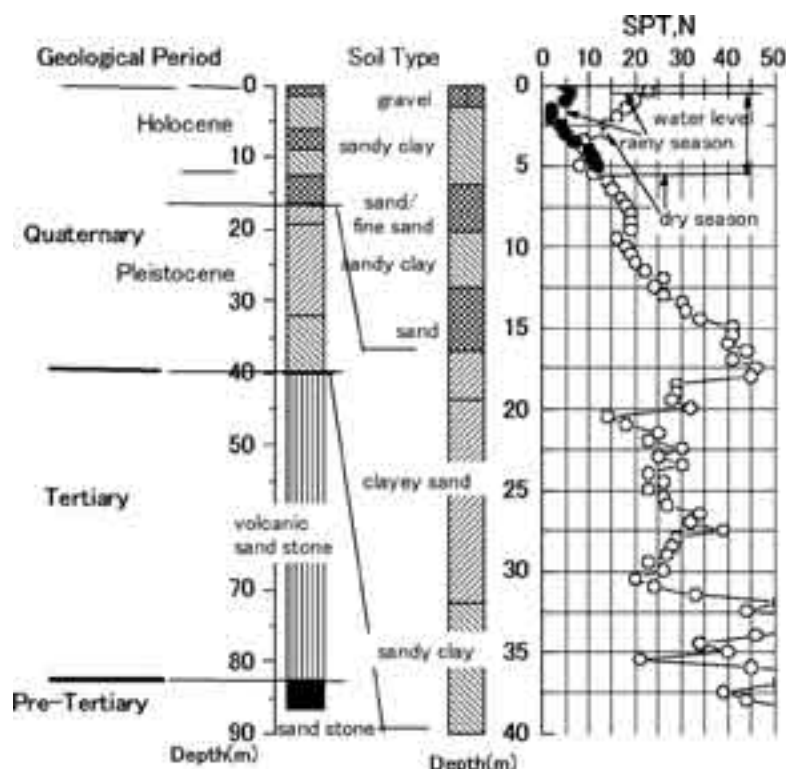
Fig. 2.5-1 Geological/Geotechnical Boring at Bayon Site.

地表面から 5m までの間は、地下水位面が変動するため、地盤の表層部の性質も変化する。乾季においては地下水位が降下し、含水比も低下する。土の含水比が低下すると不飽和状態となり土粒子間の水には負の水圧 (サクション) が作用して土は収縮して固結する。雨季となると、サクションが減少し土粒子間の接合力が弱まり、土は膨張し、軟弱となる。Fig. 2.5-1 に示したように、乾季と雨季の貫入抵抗が異なる。これは、地下水位変動によるものである。地下水位、サクション、地盤の収縮・膨張の関係を現地計測 (プラサート・スープラ地点) によって観測されたデータによれば、3m 程度の地下水の変化に伴って、3~5mm 程度の地盤のレベル変化が発生したことが確認された。このような沈下が季節変動で繰り返して発生すると、たとえ、沈下は復元性のものであっても不等沈下であると、水平の目地に発生した開口変位量は、復元しないで累積していく。このような開口変位はアンコールの石積み構造体で観察される。

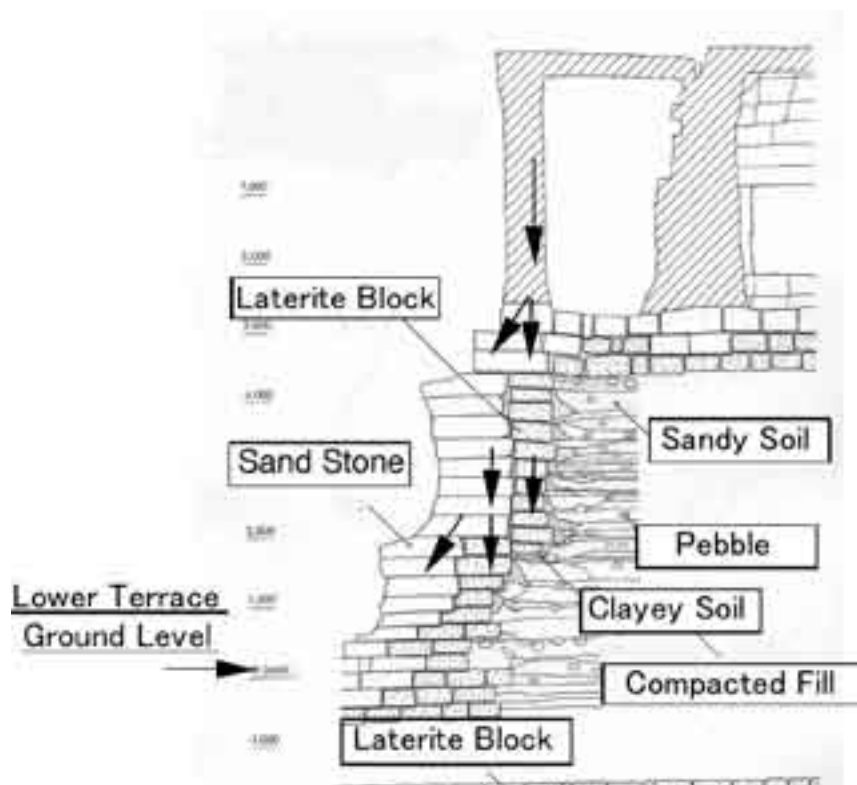
Fig. 2.5-2 Character of Stone Structure in Angkor (Arrows indicate flow line of forces).

One of typical characteristics of the foundation-structure system in Angkor is well compacted man-made fill covered by laterite blocks. Fig. 2.5-2 shows a typical example of the foundation system at Northern Library at Bayon. There are no

The pillars at the both end of the each side of the porch suffer severe settlement and porch and stairway portions are separated by continuous cracks of the stones at the side face of the platform from the central part of the main platform.

If we study carefully the arrangement of the structural element in Fig. 2.5-2, we recognize that the Upper structural load at the pillar is supported not only by stone elements but also by laterite blocks and further by manmade fill as well at lower level. If laterite blocks becomes thinner due to weathering, as clearly found at Southern Library, it is easily anticipated that differential settlements occurs and causes structural unbalance that results in failure of the upper roof structure and induces slide out of the porch portion from the platform.

Khmer engineer did not take account the different characteristics of each structural elements of sand stone, laterite block, and fill that they used. If the weak portion of laterite block suffers weathering, local settlement may take place. If the man-made fill is infiltrated by rainwater, local settlement also occurs. If these local settlements take place, differential settlements of the upper structure follow, resulting flow out of sand, and possibly final failure at the worst case.

Fig. 2.5-2 から分かるように、上部構造からの荷重を砂岩とラテライトブロックで分担し、さらに下方にはラテライトブロックの直下の盛土に分担させている。現に南経蔵で観察されるように、ラテライトブロックが風化で痩せると、不等沈下が発生して、力学的バランスが崩れて上部構造の崩壊、さらに、基壇のすべり出しを誘発する。

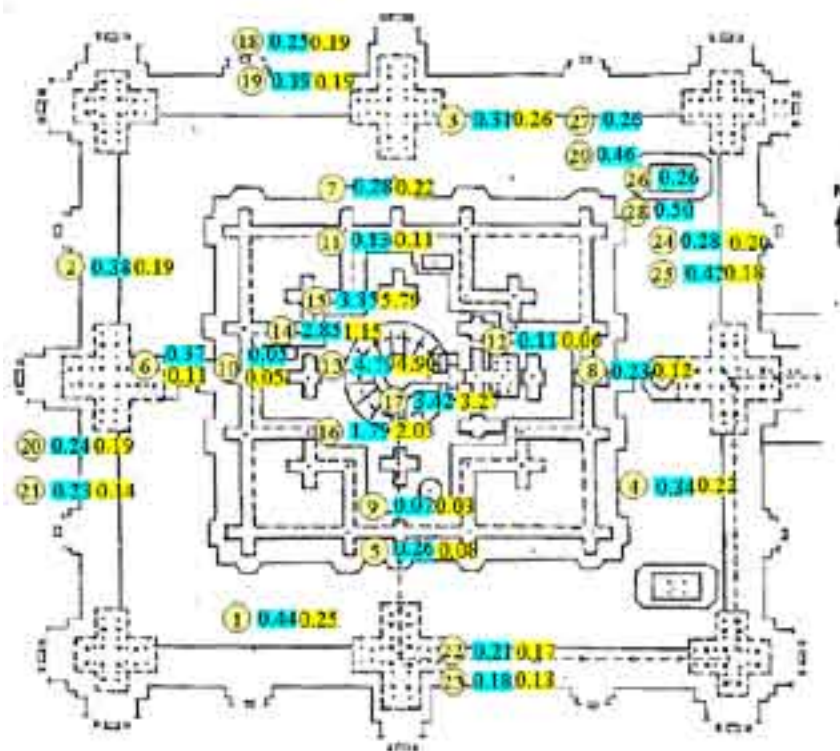
Fig. 2.6-7 The moisture content of the gray to yellowish brown sandstone blocks in Bayon. Blue color indicates the value in the wet season and yellow color that in the dry season (in %). (1)Wall in the south side of the Outer Gallery (100cm above the floor), (2)wall in the west side of the Outer Gallery (100cm above the floor), (3)wall in the north side of the Outer Gallery (100cm above the floor), (4)wall in the east side of the Outer Gallery (100cm above the floor), (5)outer wall of the south side of the Inner Gallery, (6) outer wall of the west side of the Inner Gallery, (7) outer wall of the north side of the Inner Gallery, (8) outer wall of the east side of the Inner Gallery, (9)inner wall of the south side of the Inner Gallery, (10) inner wall of the west side of the Inner Gallery, (11) inner wall of the east side of the Inner Gallery, (12) inner wall of the north side of the Inner Gallery, (13)inner wall of the Central Sanctuary(central part), (14) inner wall of the Central Sanctuary(west part), (15) inner wall of the Central Sanctuary(northwest part), (16) inner wall of the Central Sanctuary(south part), (17) inner wall of the Central Sanctuary(southeast part), (18)inner pillar of the north side of the Outer Gallery(165cm above the floor), (19) inner pillar of the north side of the Outer Gallery(45cm above the floor), (20) inner pillar of the west side of the Outer Gallery(165cm above the floor), (21) inner pillar of the west side of the Outer Gallery(45cm above the floor), (22) inner pillar of the south side of the Outer Gallery(165cm above the floor), (23) inner pillar of the south side of the Outer Gallery(45cm above the floor), (24) inner pillar of the east side of the Outer Gallery(165cm above the floor), (25) inner pillar of the east side of the Outer Gallery(45cm above the floor), (26)inner wall of the south side of the Northern Library, (27)inner wall of the north side of the Northern Library, (28)outer wall of the south side of the Northern Library, (29)outer wall of the north side of the Northern Library.

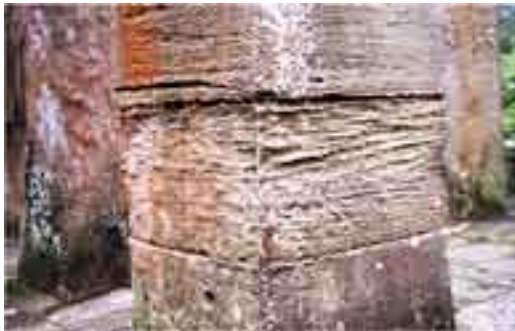
Pl. 2.6-10 Emphasized bedding planes due to tafoni in the pillar in the southeast corner building of the Outer Gallery of Bayon.

パイヨン外回廊の南東角にある建造物の柱に見られるタフォニにより顕著となった層理面。

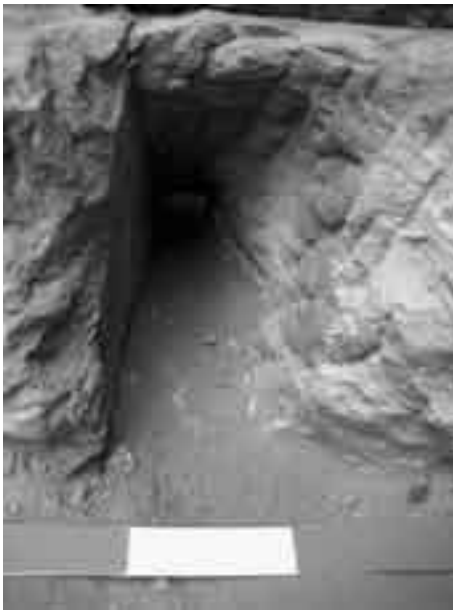
Pl. 2.8-7 Drain G-7, Chisel traces (additional drain).

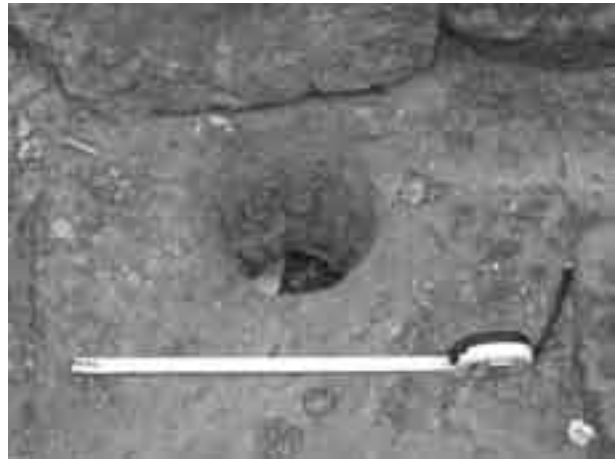
Pl. 2.8-8 Drain D-1, Inlet.

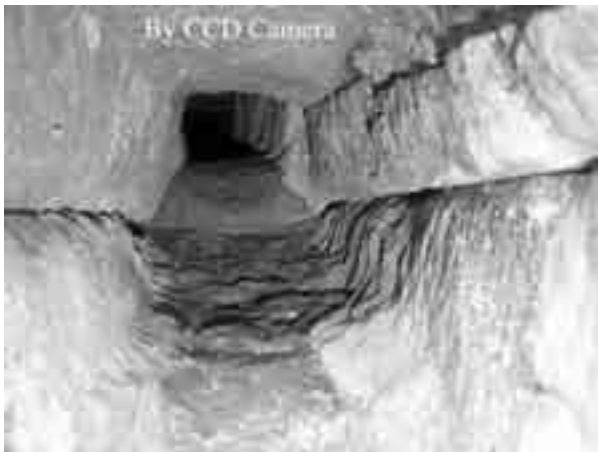
Pl. 2.8-9 Drain D-1, Internal structure.

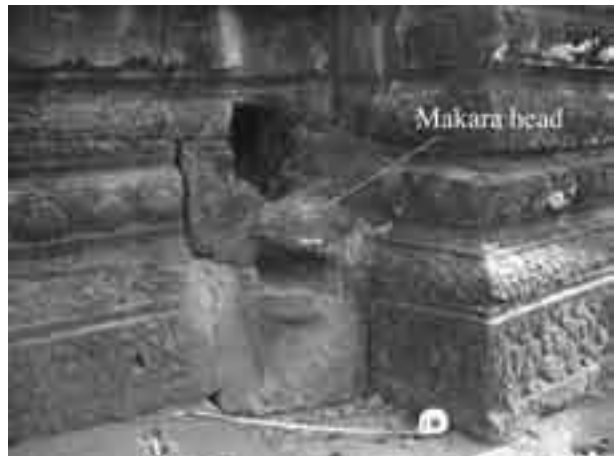
Pl. 2.8-10 Drain D-1, Outlet.

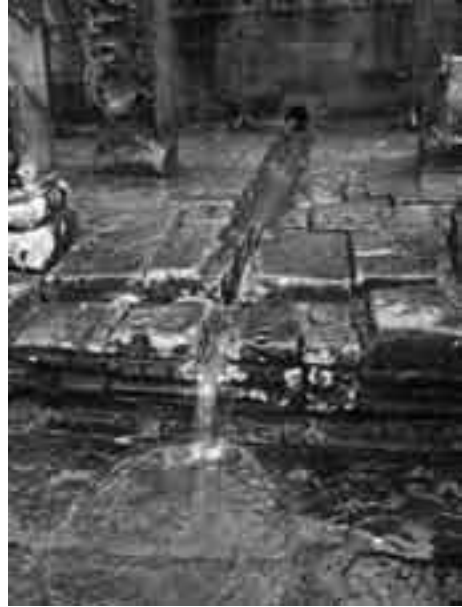
Pl. 2.8-21 Drain G-2, drain works.

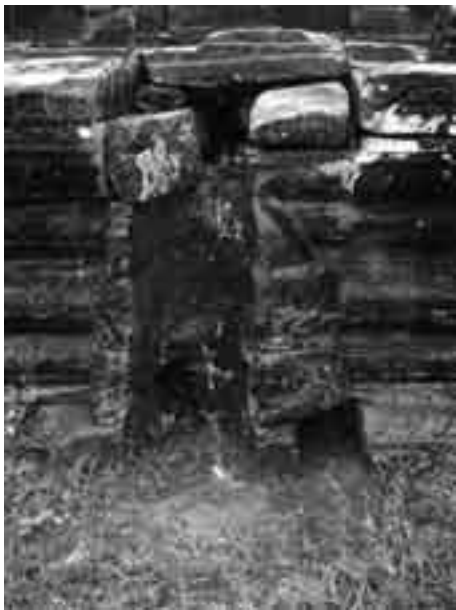
Pl. 2.8-22 Drain G-4, culvert G-4, C1 and G-4, C2.

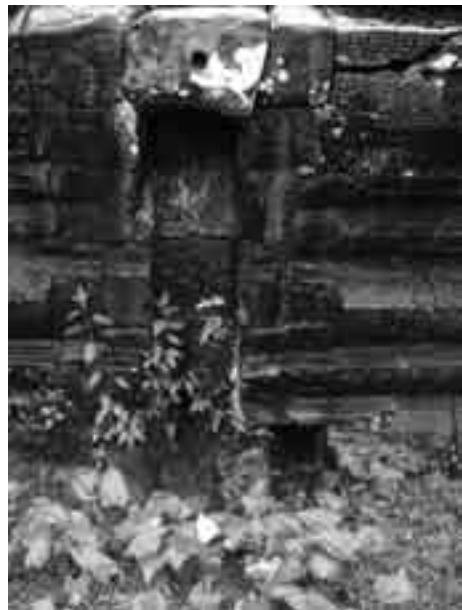
Pl. 2.8-23 Drain G-5, culvert G-5, C1 and G-5, C2.

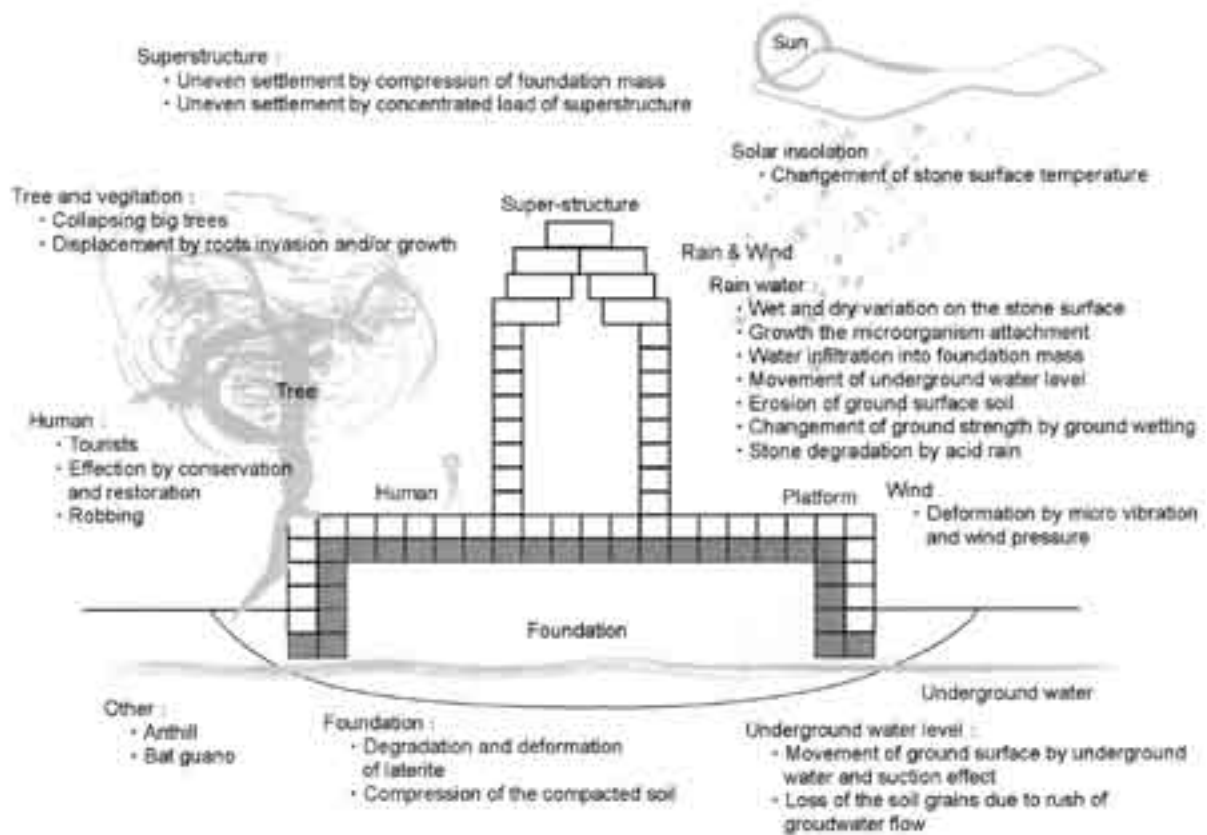
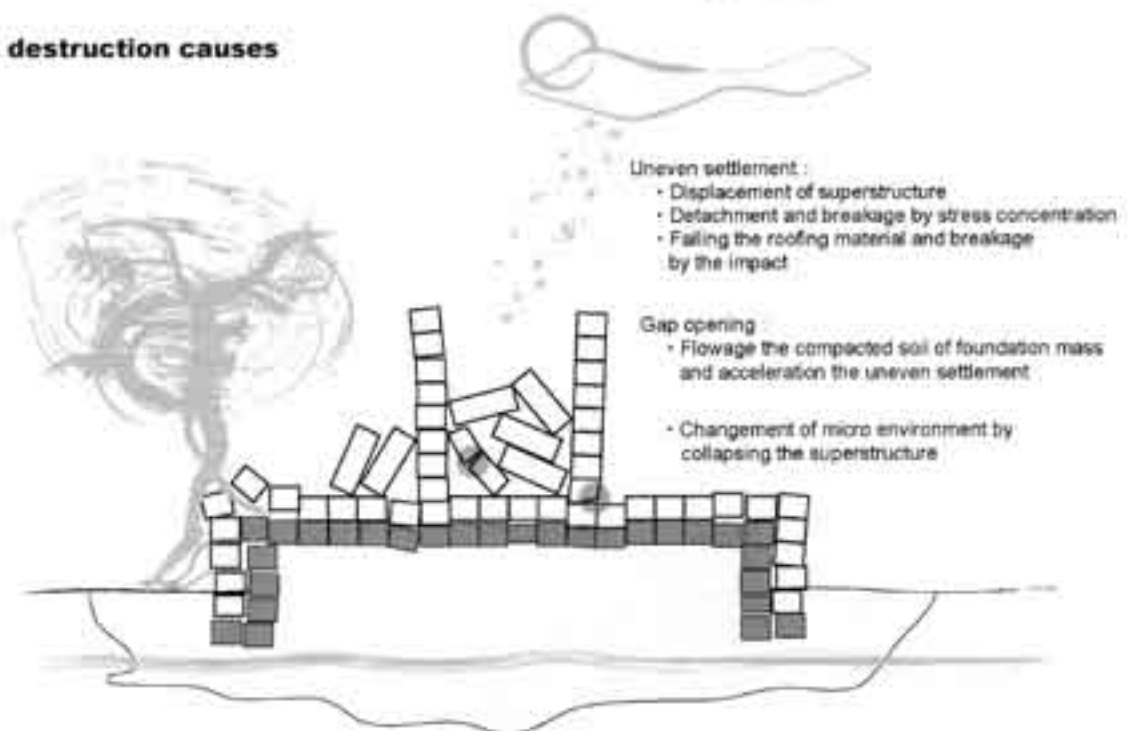
Fig. 3-1 Destruction and degradation causes.

破損と劣化は関連した多様なプロセスの中で説明される (Fig. 3-1)。多種の劣化因子により石材の物性が低下することで構造体の破損を誘発する一方、構造体が破損することによる微気象変化や応力変化により劣化は別の段階へと移行する。特に、ラテライトや版築盛土といった材料は劣化が進行しており、構造上致命的となる破損を引き起こす主因となっている。

The following diagram exhibit how the process and mechanism of destruction and degradation works under such complex context. (Fig. 3-1) While degradation on a stone element progressively degrades due to various causes instigate physical destruction of the structure, destruction caused by various problems changes the equilibriums by altering microclimatic condition or internal force brings degradation of elements to another degree. Especially, the degradation of laterite and compacted earth hidden underneath of sandstone superstructure are in progress without being detected that could bring forth detrimental destruction that affect the structure as a whole.

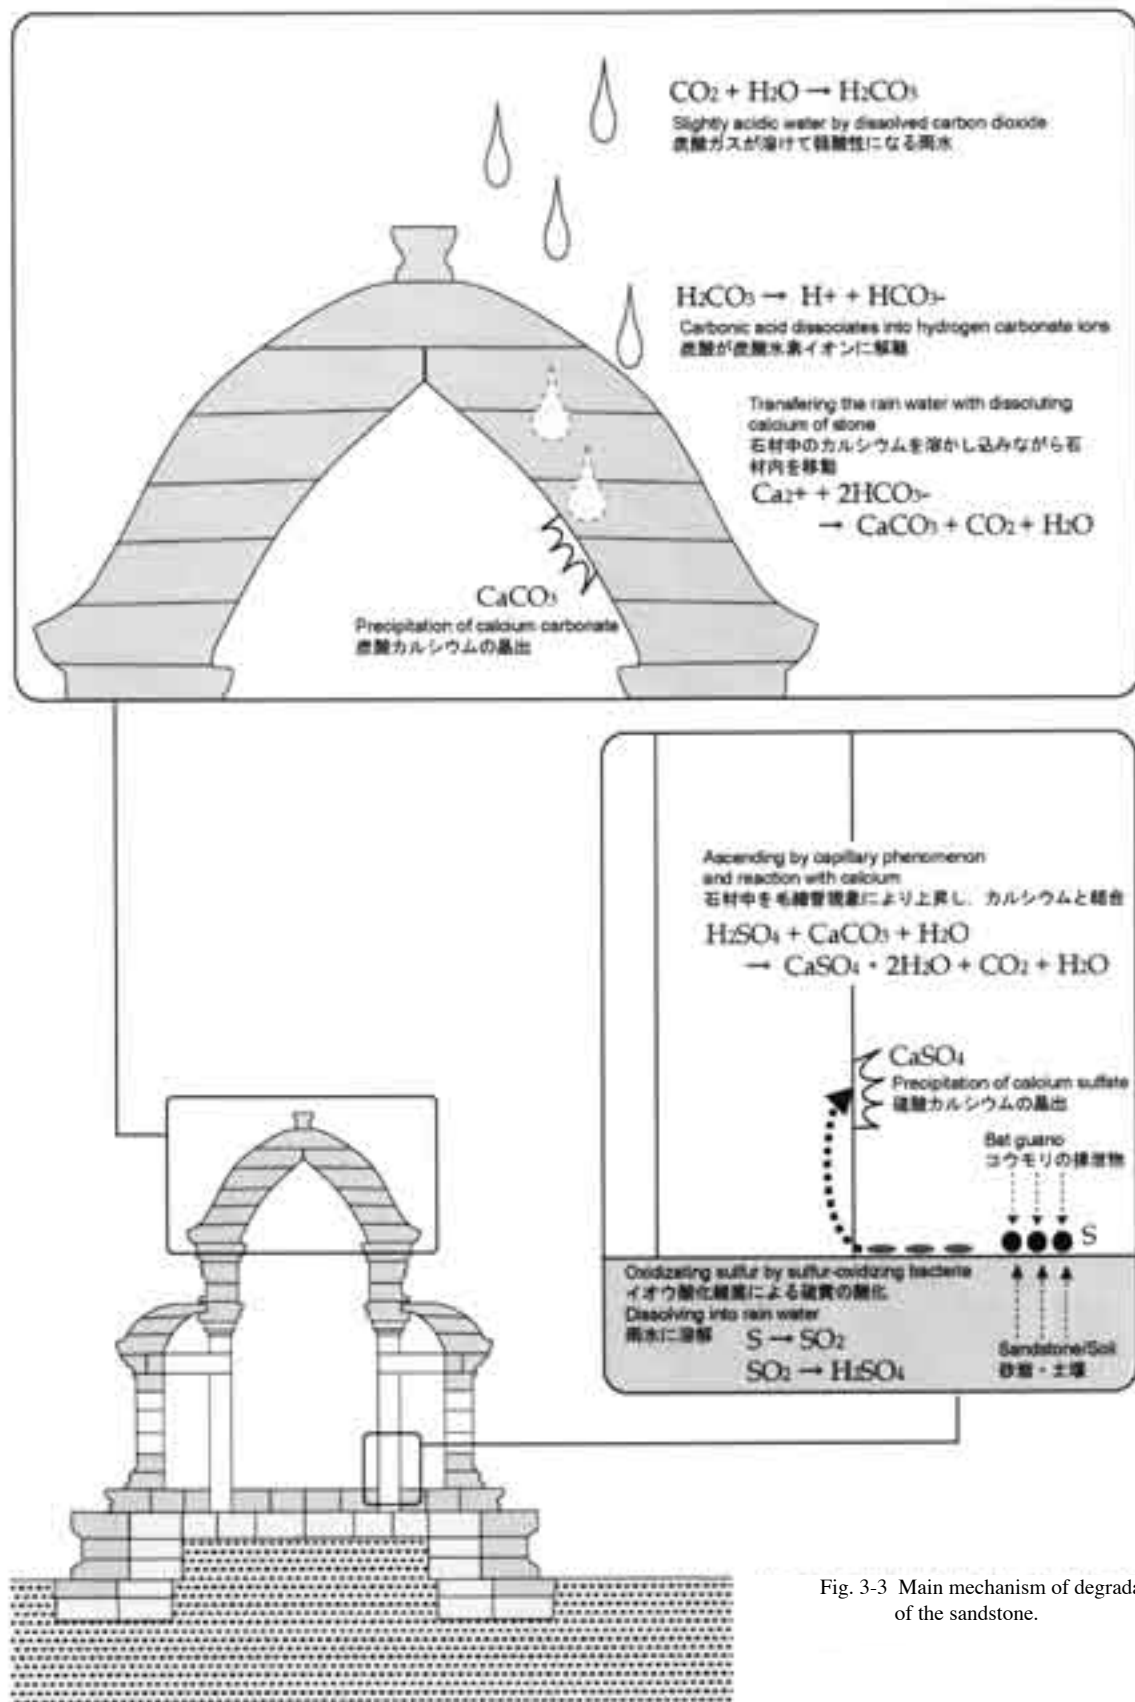
Fig. 3-3 Main mechanism of degradation of the sandstone.

#### 4.3 主要な塩類風化のプロセス (Fig. 3-3)

### 4.3 Principal process of efflorescence appeared in the Bayon (Fig. 3-3)
