- Appendix 6 : Building Structural Survey Report of the Bayon Temple
- 6.1 Building Structural Survey of the Bayon Temple and so forth
 - Bayon Northern Library, Prasat Suor Prat, and Angkor Wat Northern Library -

IWASAKI Yoshinori, ARAYA Masato

1. Introduction

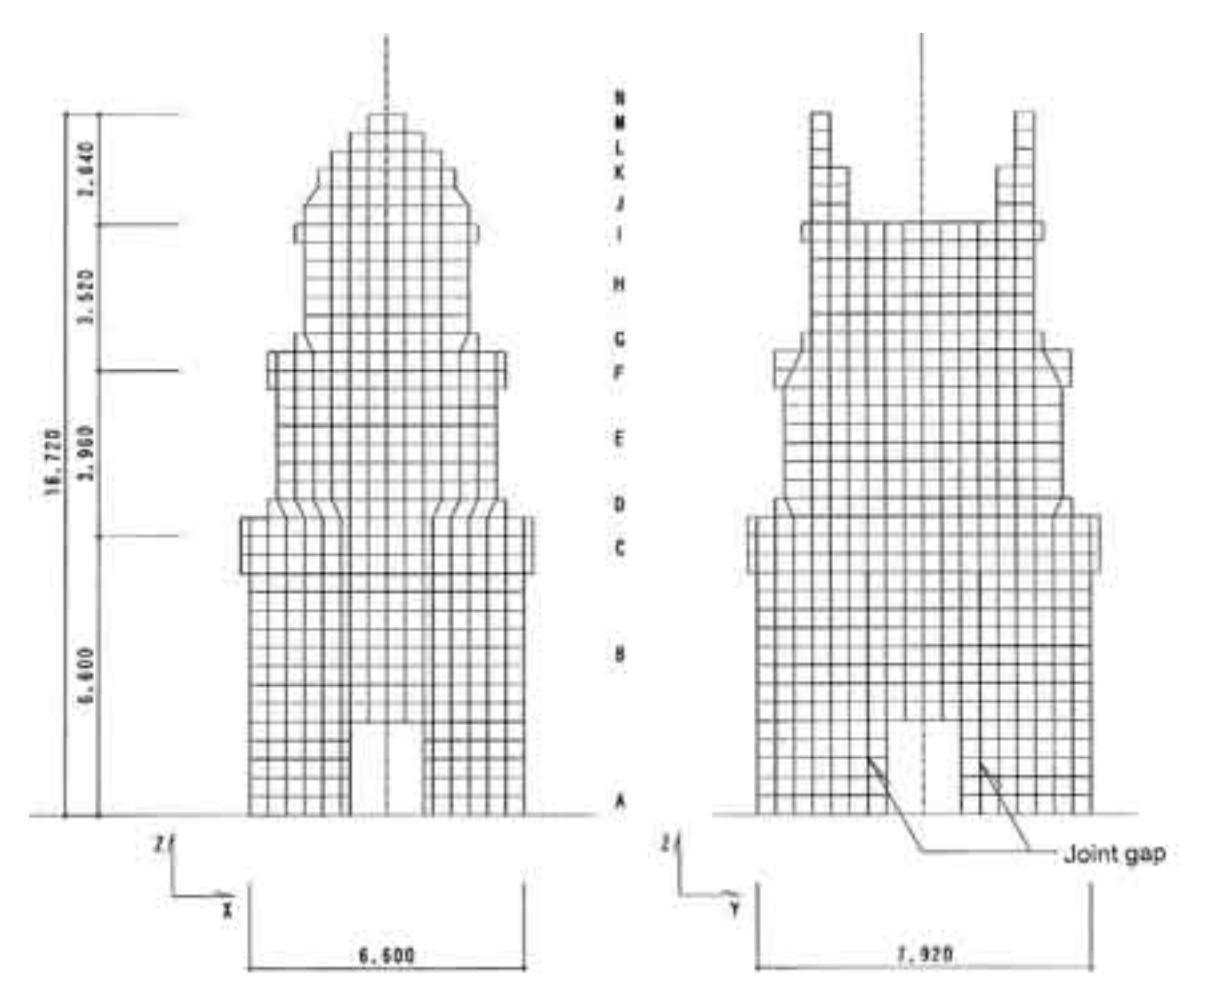
Fig. 6.1-10 Slit model: Joint gap to simulate cracks in the tower structure.

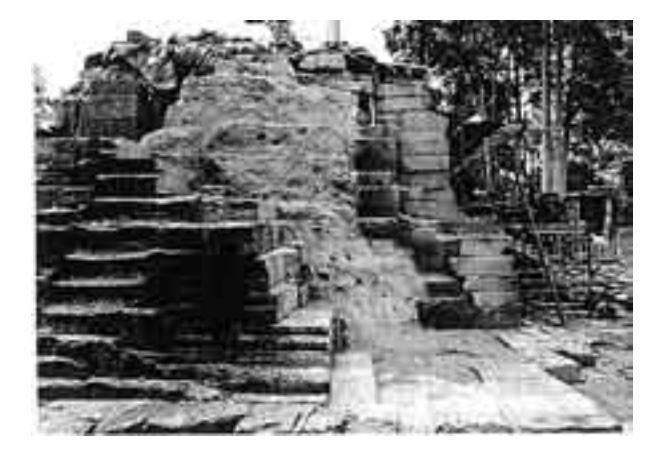
Pl. 6.1-1 Dismantling of south-west corner.

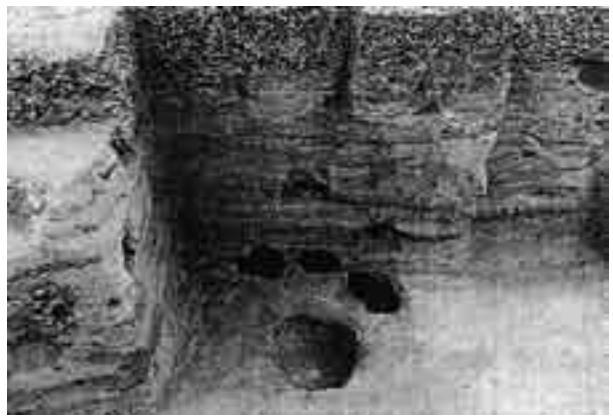
Pl. 6.1-2 Traces of ant's nest, compacted mound, Northern Library, Bayon.

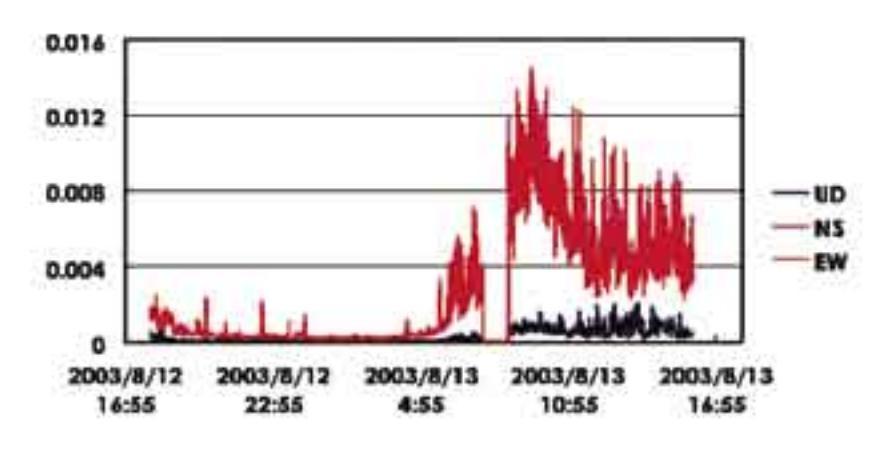
In Fig. 6.2.1-4.5, the changes in micro-tremor intensities measured all through the day and night at the top of the Bayon central tower are shown in RMS values.³ No measurement was taken between 7:30 and 9:00 am, due to battery replacement. The average RMS value for the horizontal component was 2×10^{-4} gal during the night and 6×10^{-3} gal during the daytime. This means that the daytime value was more than ten times greater than the nighttime value. The difference in values can be attributed to the averagely high micro-tremor intensities during the daytime caused by external vibrations such as of people and traffic.

Fig. 6.2.1-4.5 Micro-tremor intensities at the top of the Bayon central tower (RMS : gal).

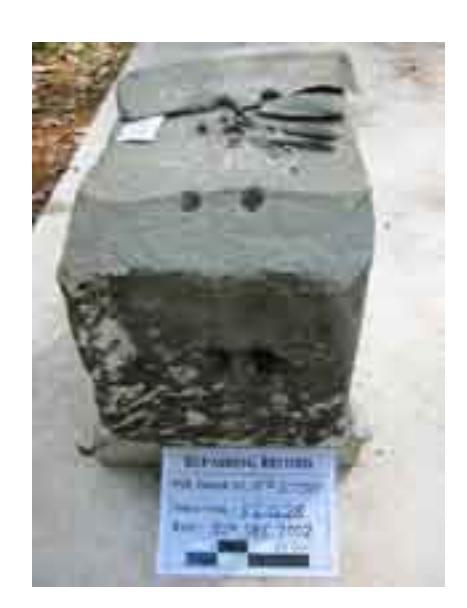
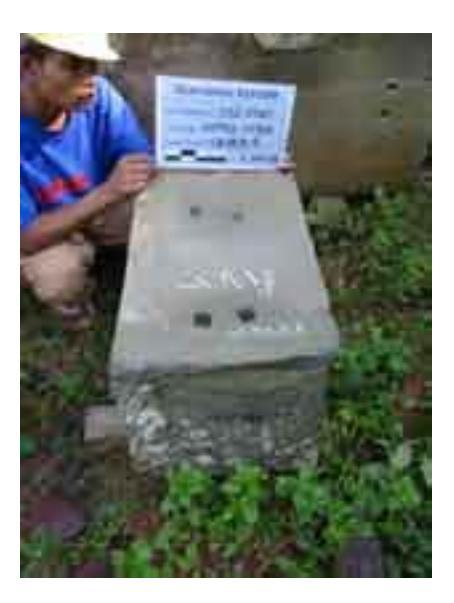
Case 1: Attachment of small fragments.

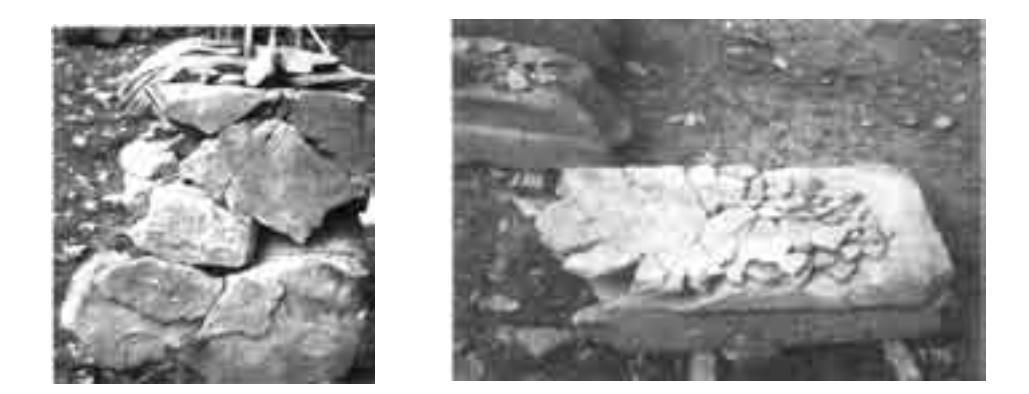
Case 2: Reassembling for recording purposes.

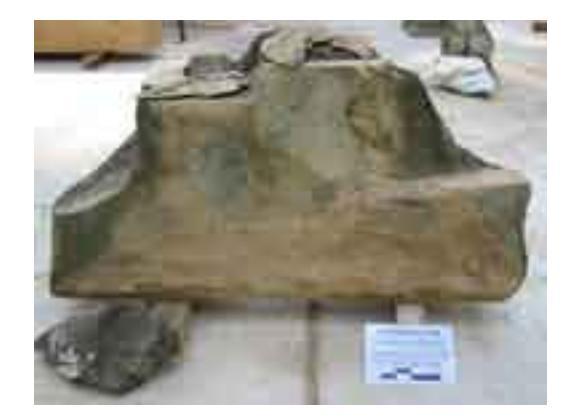
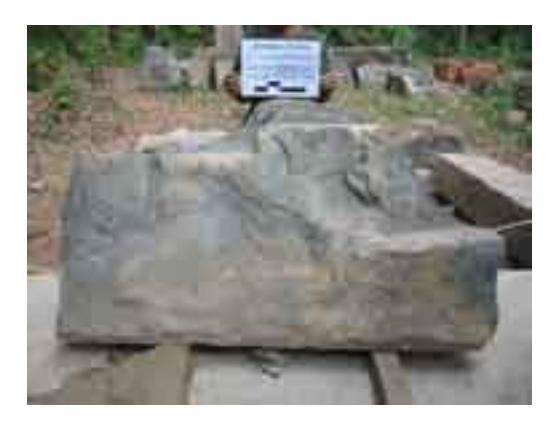
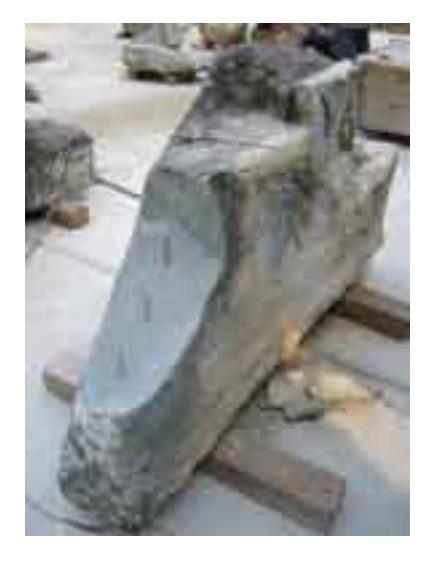
Case 3: Stone bonding of uncomplicated detachments.

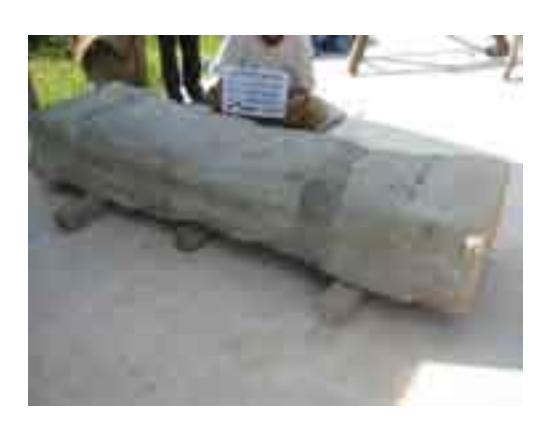
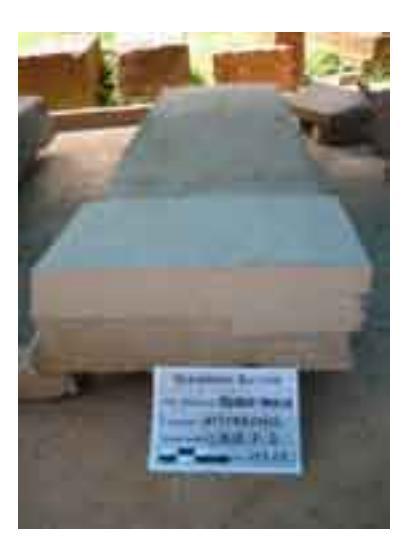
Case 4: Filling of missing sections.

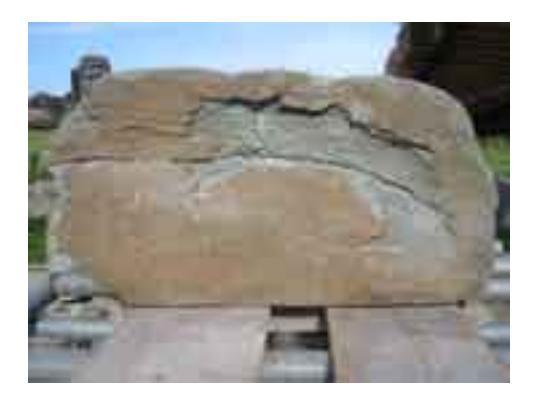
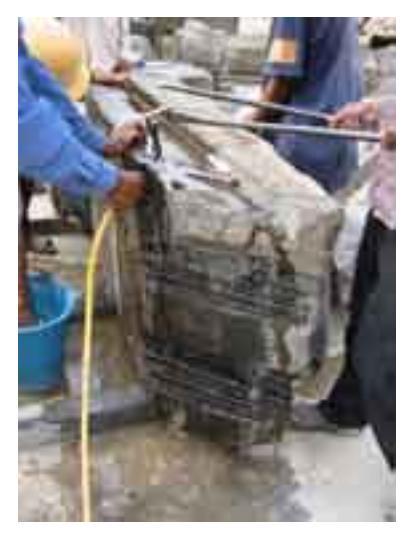
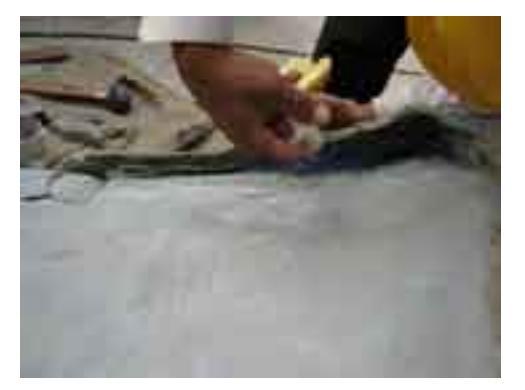
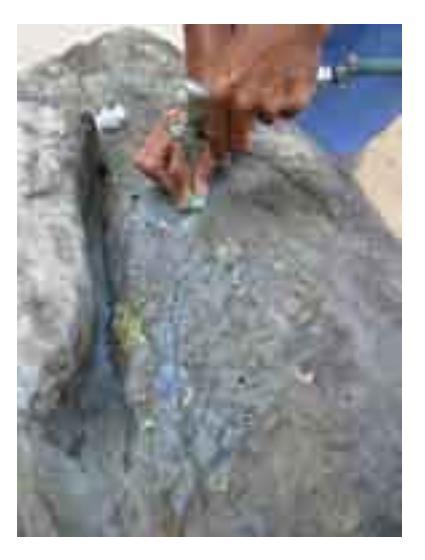
Case 5: Consolidation of fissile materials.

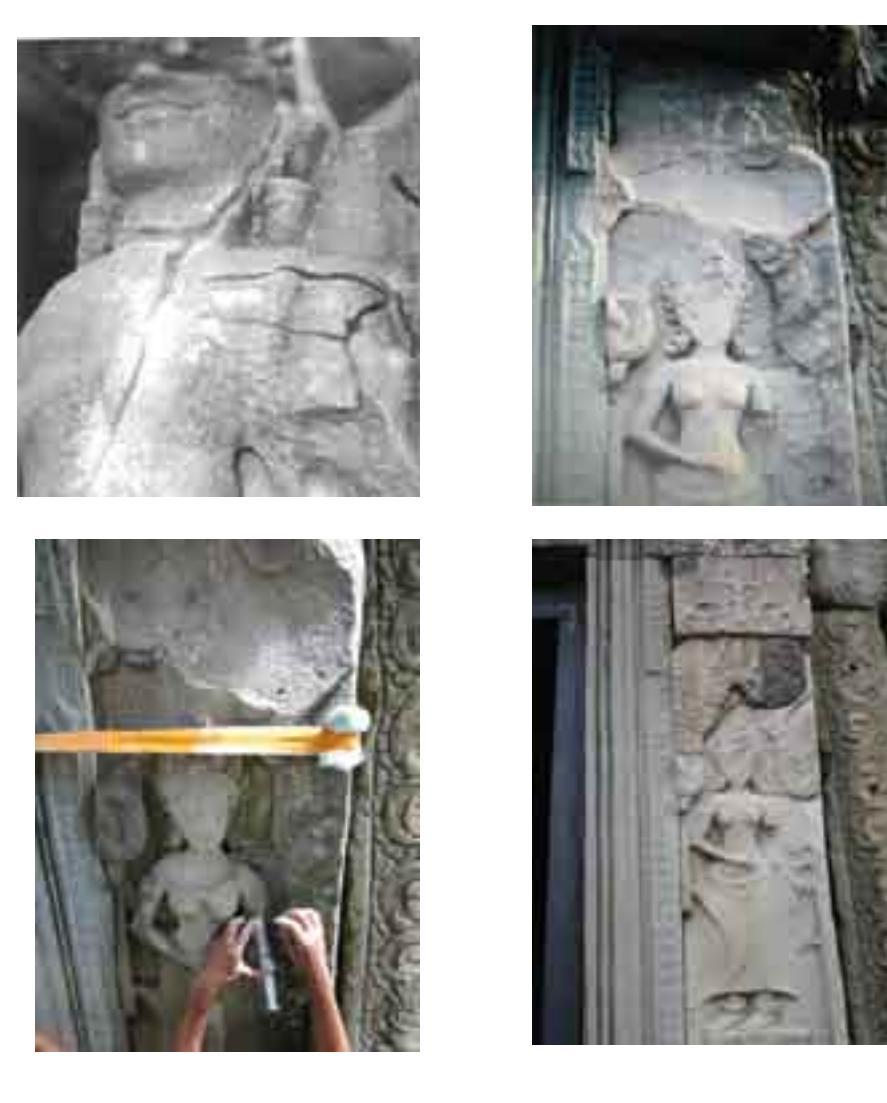
Case 6: Reattachment of detached section with carving.

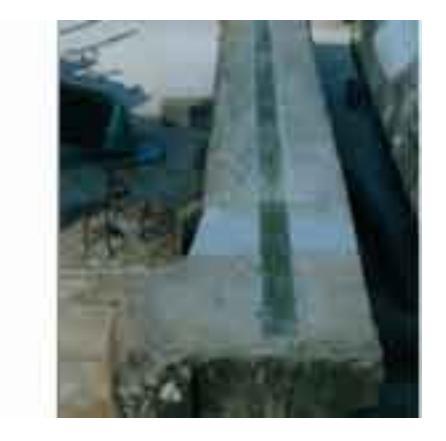
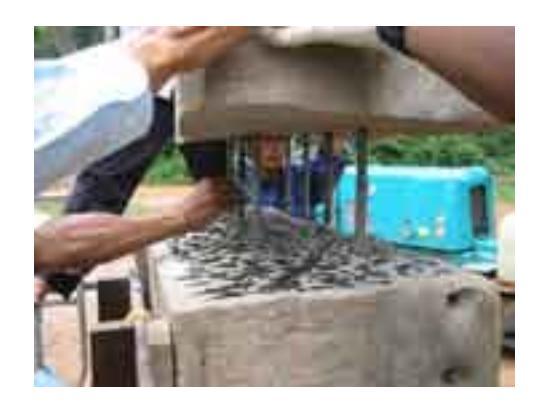
Case 7: Constructional reinforcement.

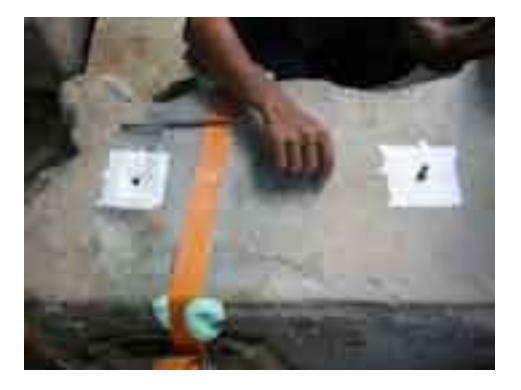
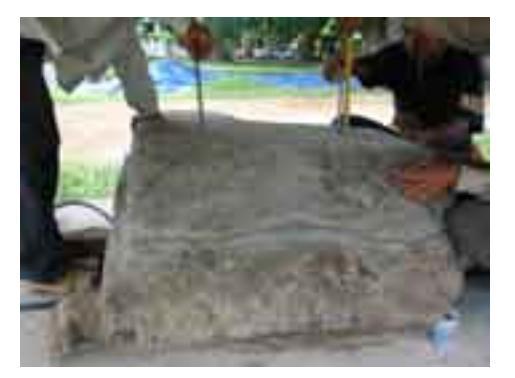
Case 8: Fixing continued cracks.
